Hydrogeologic Appraisal of a Fractured-Rock Groundwater Contamination Site -- A Discrete-Zone Approach

Generalized Site Geology

Bedrock Borehole Installation

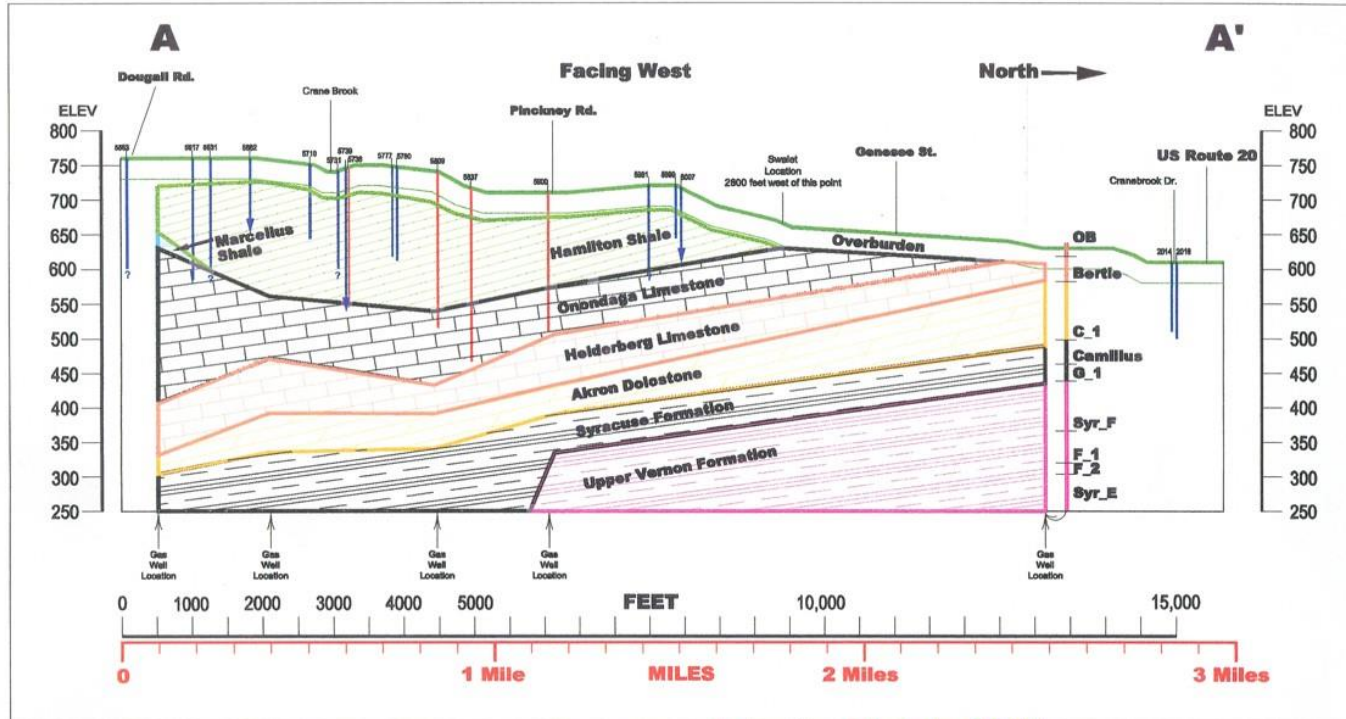
Cross-Section Projected along Bluefield and Experimental Roads
Geology from gas wells on file in the Division of Mineral Resources

Vertical exaggeration = 10X.

670 Street Number Domestic waterwell, not showing chlorinated compounds, "ND"	670 Street Number Domestic waterwell, at least as deep as shown
688 Street Number Domestic waterwell showing contamination from chlorinated compounds	676 Street Number Domestic waterwell, depth not known

Geologic correlations were made based upon well completion reports on file at DMR, Central Office. Gas well logs of these same locations record different unit names, as shown for the northernmost gas well.

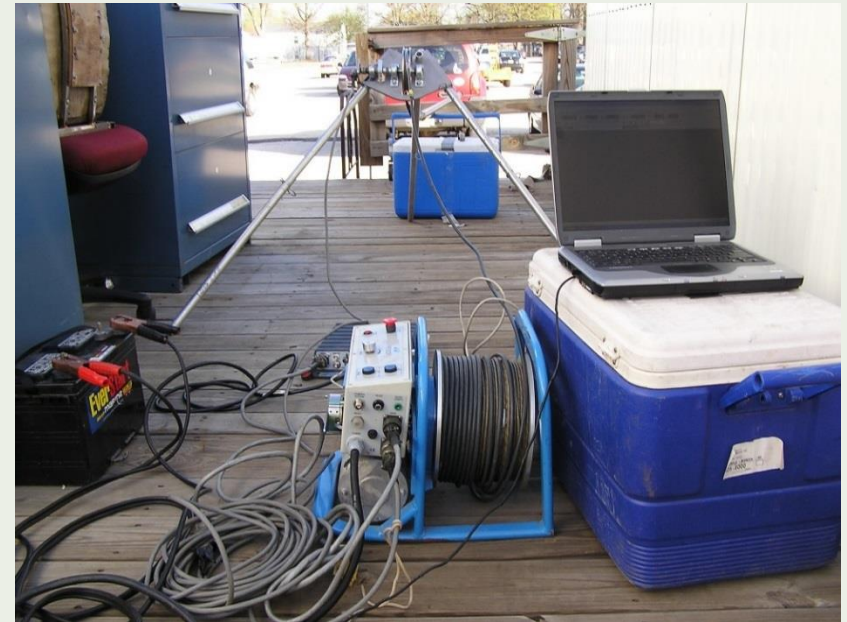
- Borehole video logging conducted by U.S. EPA Environmental Response Team
- Cascading groundwater observed entering boreholes above static well water levels

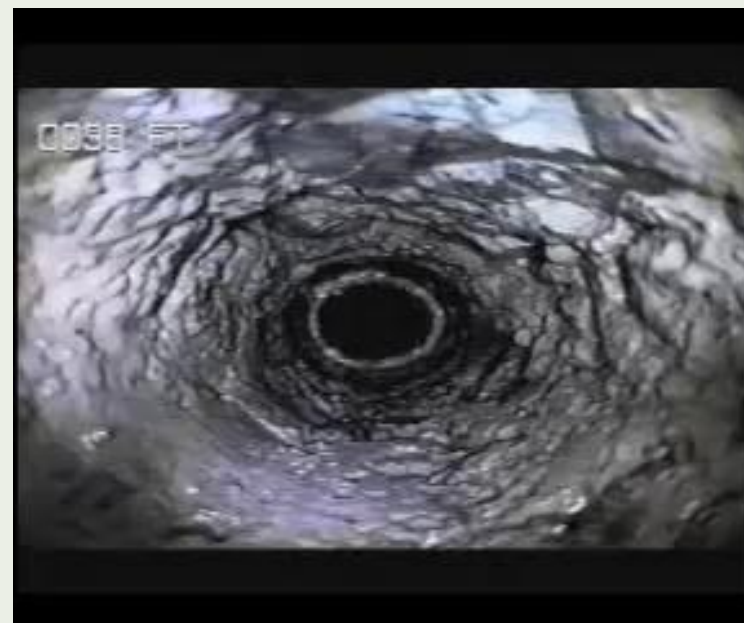
- **Borehole video logging conducted by U.S. EPA Environmental Response Team**
- **Cascading groundwater observed entering boreholes above static well water levels**
- **Cored borehole**

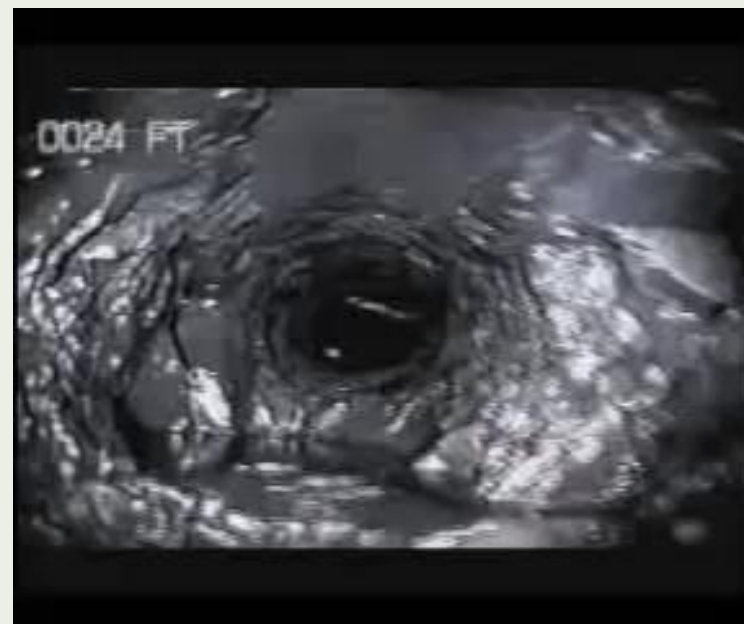
- Borehole video logging conducted by U.S. EPA Environmental Response Team
- Cascading groundwater observed entering boreholes above static well water levels
- Air hammer drilled borehole

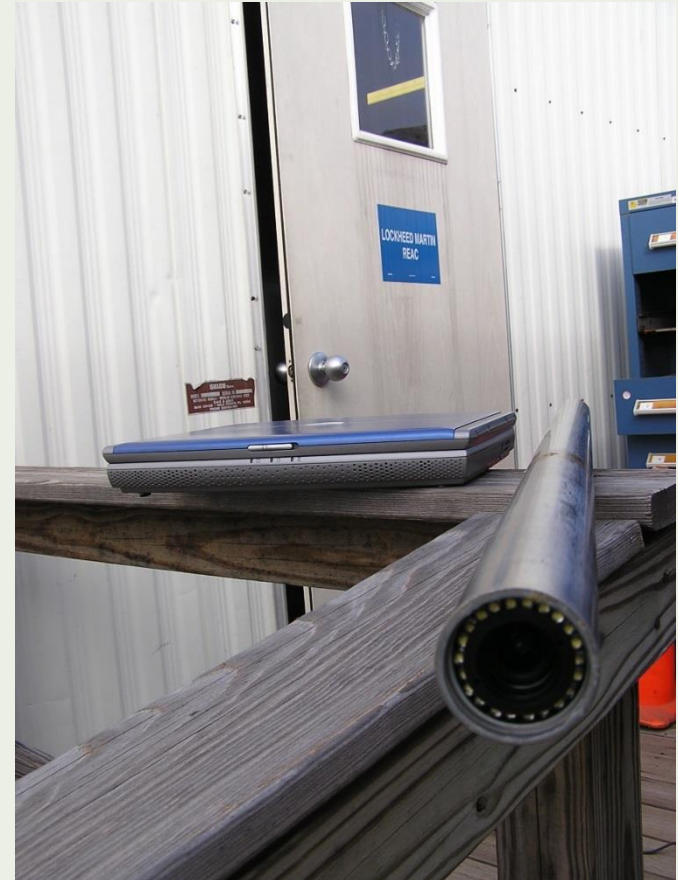
- Borehole video logging conducted by U.S. EPA Environmental Response Team
- Cascading groundwater observed entering boreholes above static well water levels
- Solution void zone observed within the Forge Hollow Member of the Bertie Formation

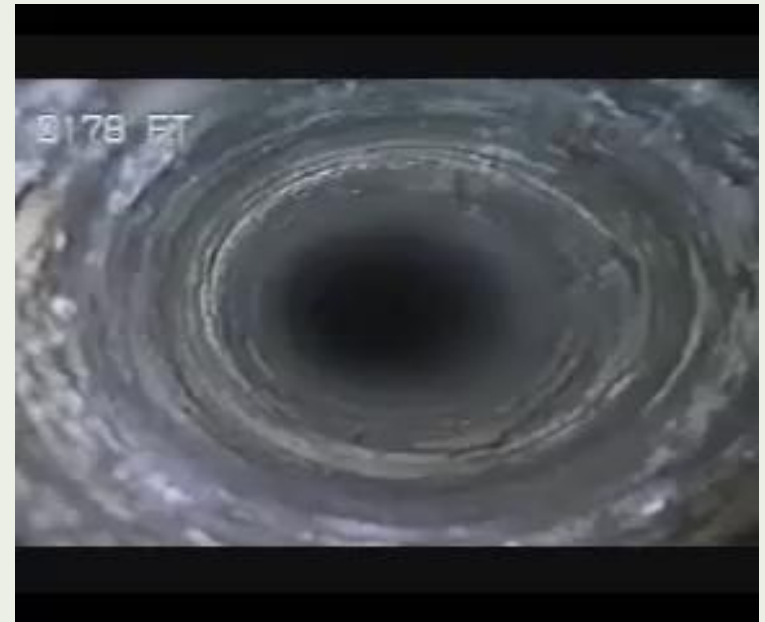
- **Solution void zone in the Forge Hollow Member of the Bertie Formation**

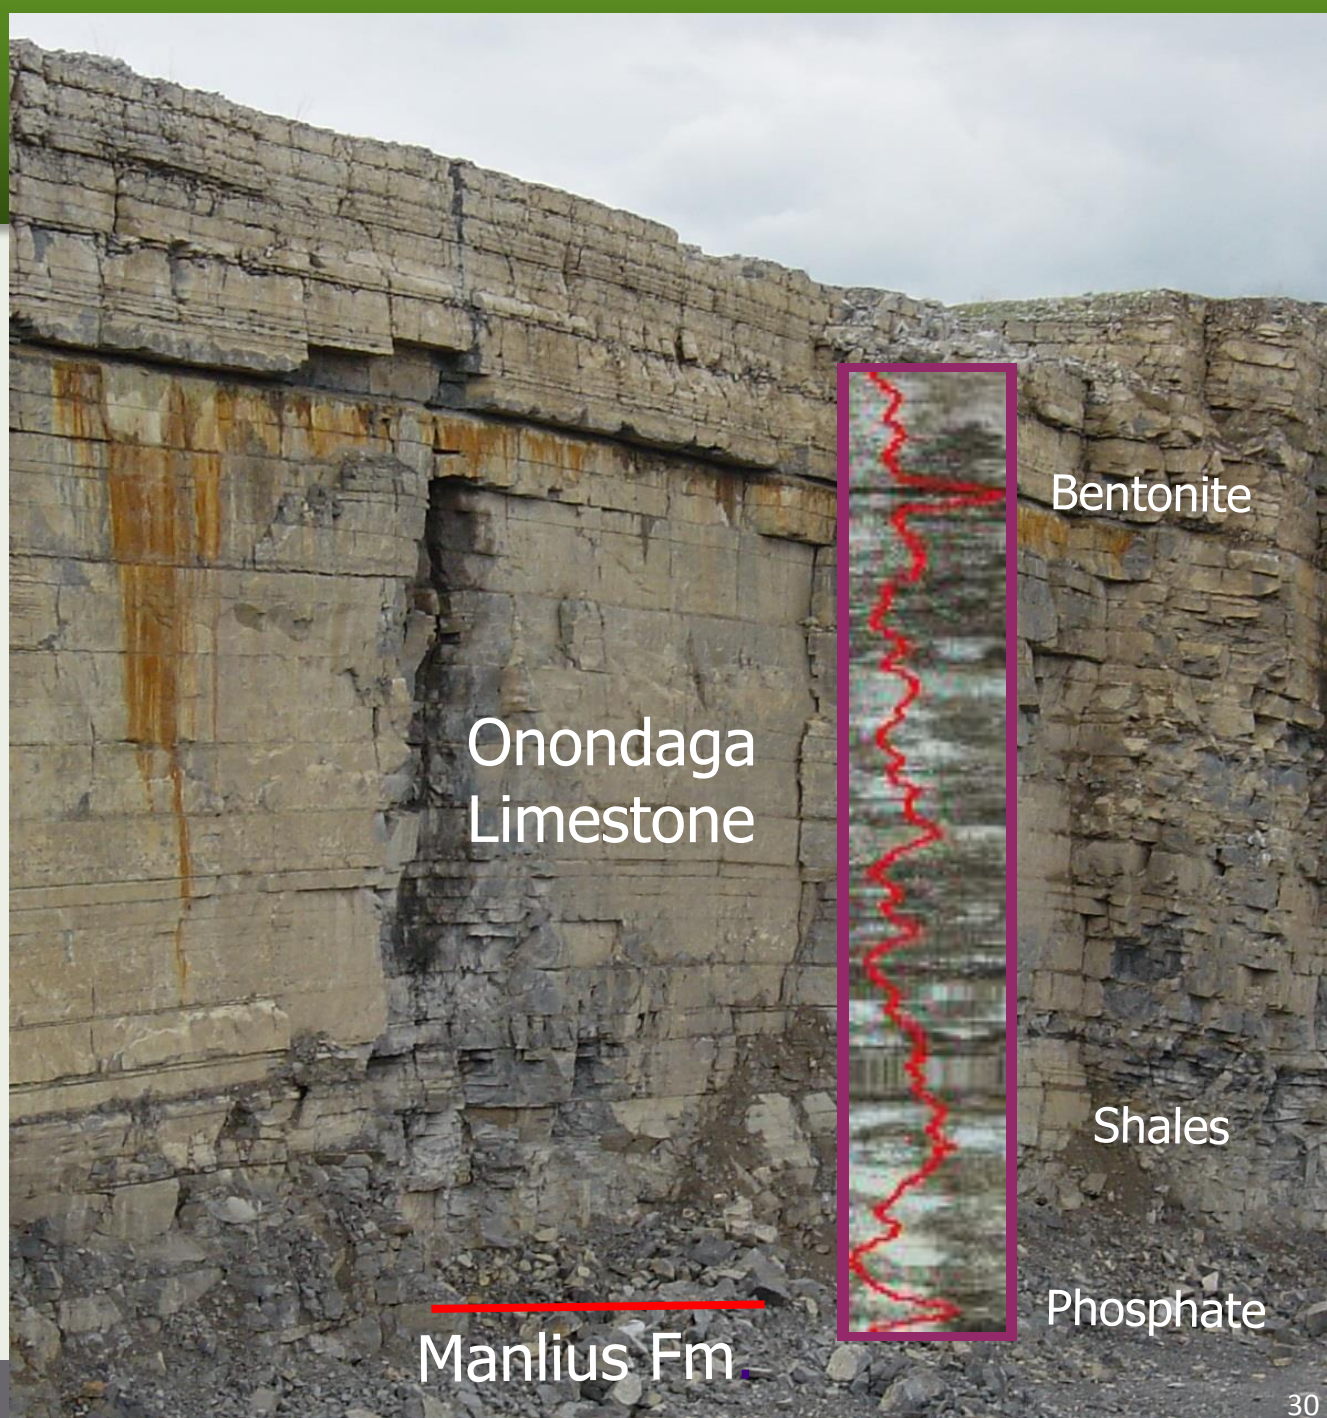
Use of typical stratigraphic marker beds that are easily identified in gamma logs

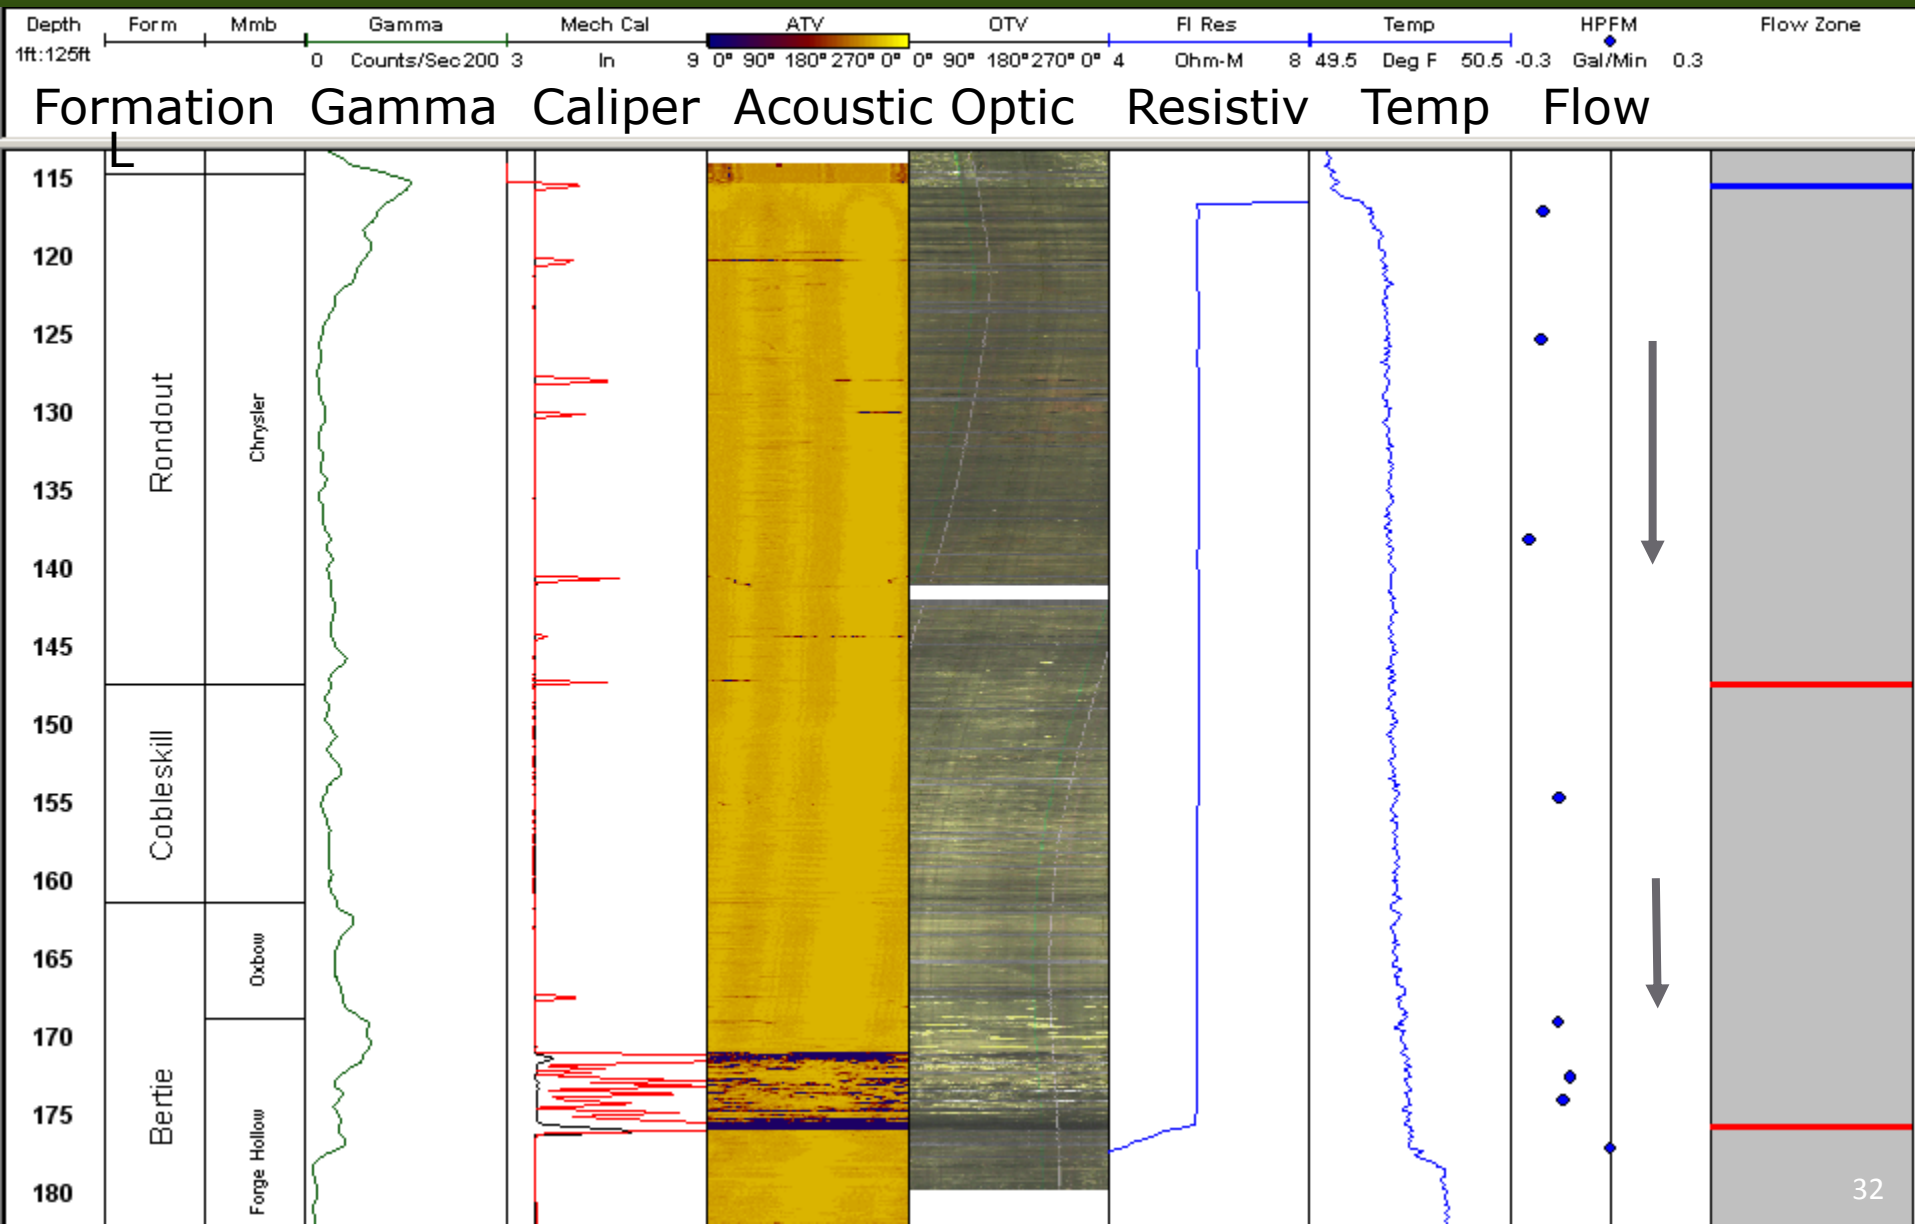
Geophysical, Stratigraphic, and Flow-Zone Logs EPA-1

- **Borehole video logging conducted by U.S. EPA Environmental Response Team**
- **Gamma, caliper, and temperature geophysical logging conducted by U.S. EPA Environmental Response Team**
- **Heat-pulse flowmeter, and optical and acoustic televiewer geophysical logging conducted by U.S. Geological Survey**

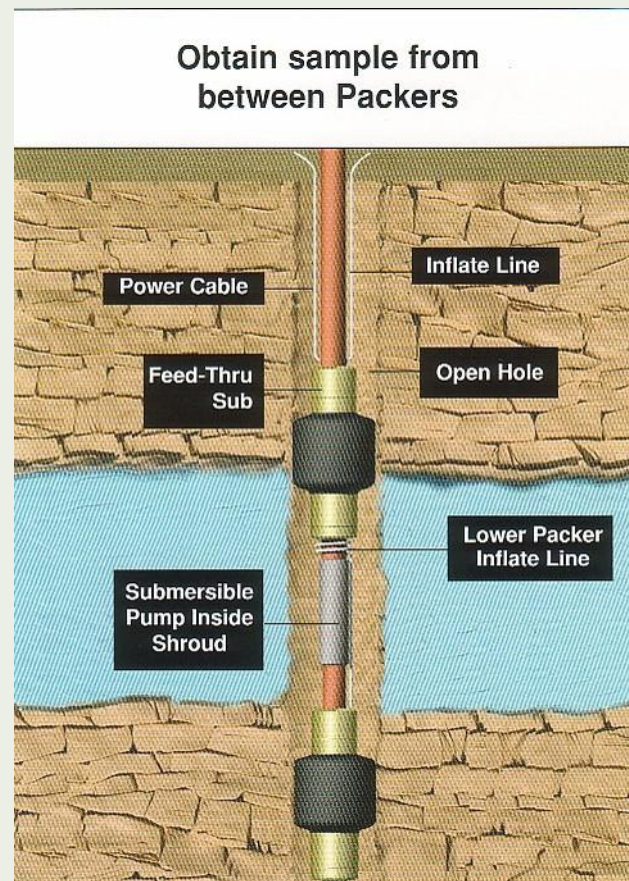
- Subsequent to drilling and concurrent with borehole video and geophysical logging, each boring was sampled using straddle packer assemblies

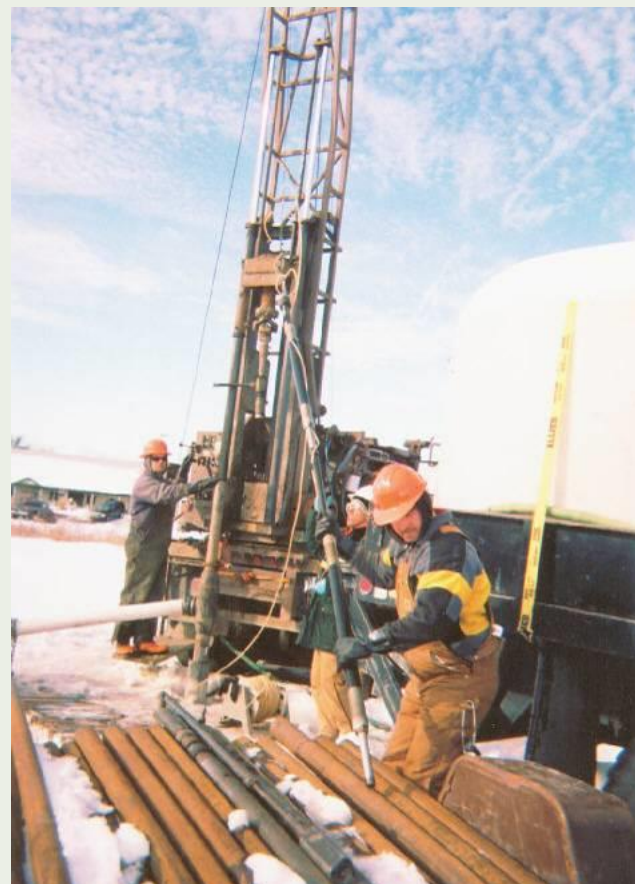
- Subsequent to drilling and concurrent with borehole video and geophysical logging, each boring was sampled using straddle packer assemblies
- Intervals sampled were selected based on bedrock core examined, notes made during drilling, and borehole video and geophysical data

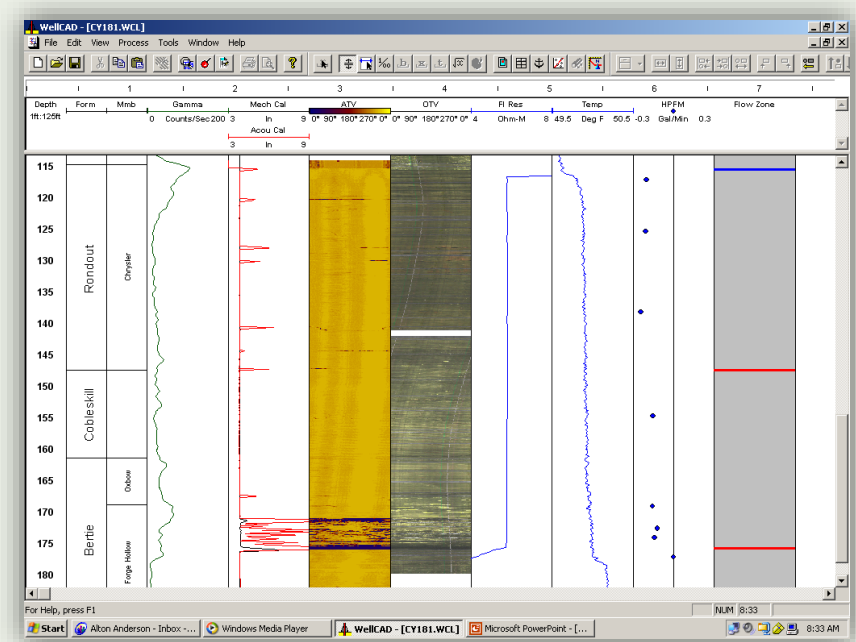
- Boreholes (within the plume) were found to have VOCs in the transmissive zone of the Forge Hollow Member of the Bertie Formation
- Contaminated zone was discovered to be diluted by clean water flowing vertically downwards from clean upper zones

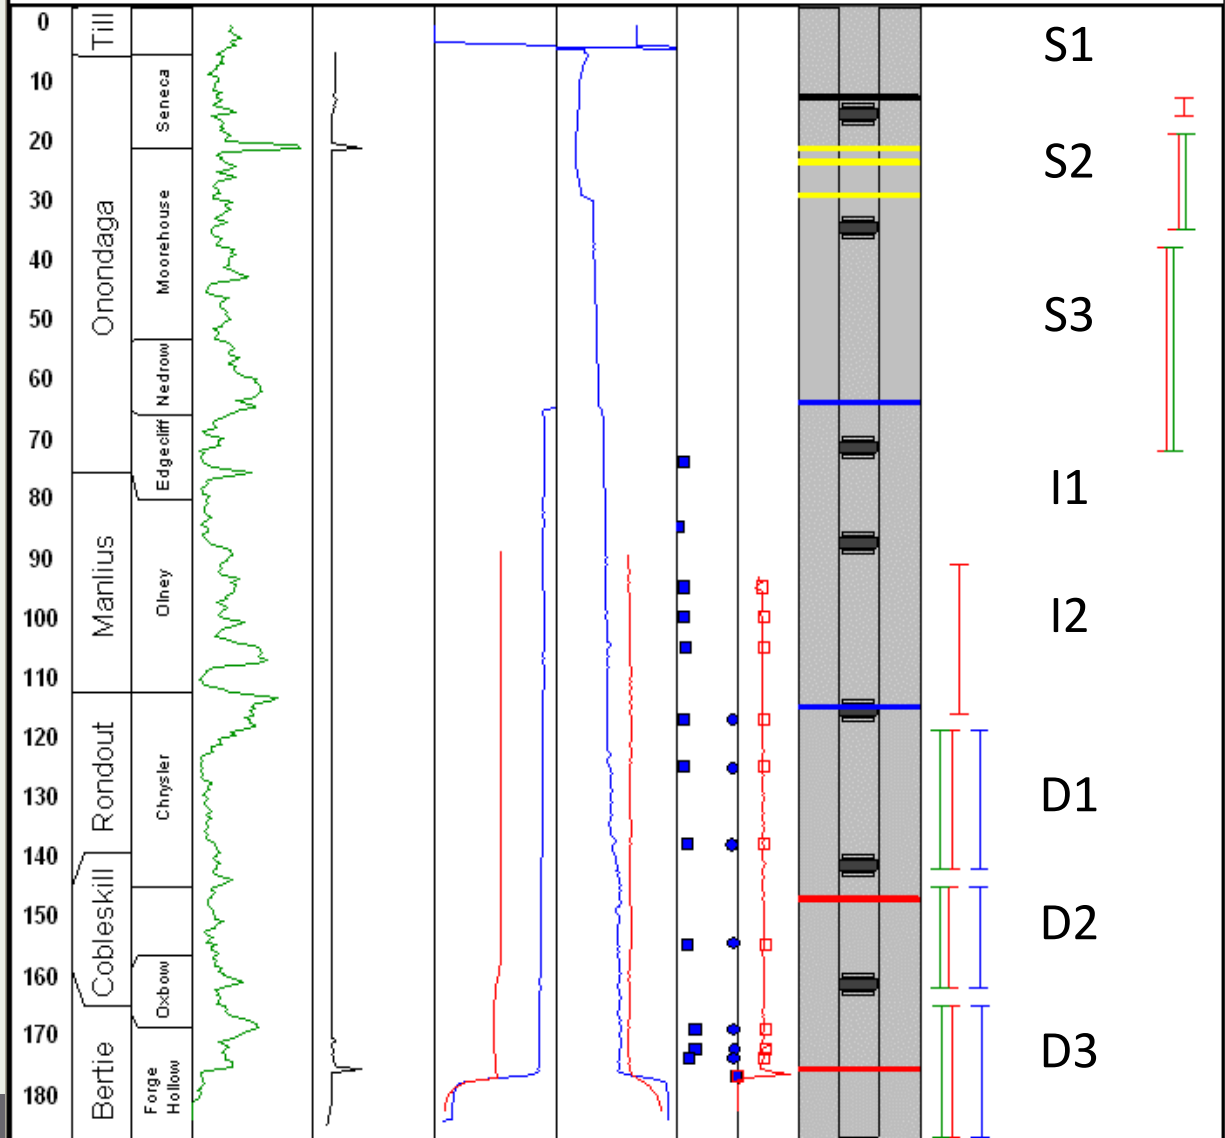
EPA-1

Cobleskill Fm D2

Bertie Fm D3

8 discrete zones
